This thesis entitled "Post-Impact Fatigue of Cross-Plied, Through-the-Thickness Reinforced Carbon/Epoxy Composites" and written by Thomas E. Serdinak is presented to the Graduate School of Clemson University. I recommend that it be accepted in partial fulfillment of the requirements for the degree of Master of Science with a major in Engineering Mechanics.

(NASA-TM-110625) POST-IMPACT
FATIGUE OF CROSS-PLIED,
THROUGH-THE-THICKNESS REINFORCED
CARBON/EPOXY COMPOSITES M.S. Thesis
- Clemson Univ. (NASA Langley
Research Center) 176 p

UTTL: Post-impact fatigue of cross-ply, through-the-thickness reinforced
carbon/epoxy composites TLSP: M.S. Thesis - Clemson Univ.

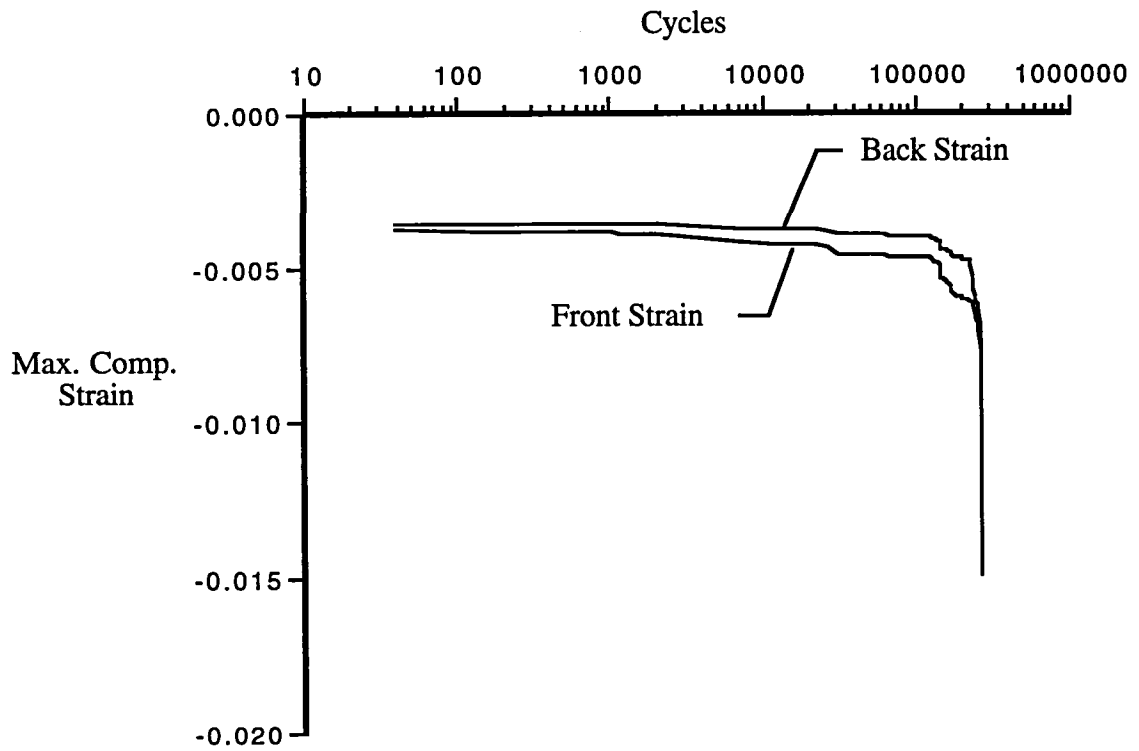
Figure 28. Maximum compressive strain from front and back extensometers throughout a typical fatigue test (IM6 carbon TTT reinforcement).

The relevance of amount of bending incurred is not clear. Local bending (determined from extensometer data) is not a direct indicator of damage growth. Global bending, caused by warped samples or loading misalignment, also influences local bending. Additionally, measured bending strain was artificially elevated due to the method

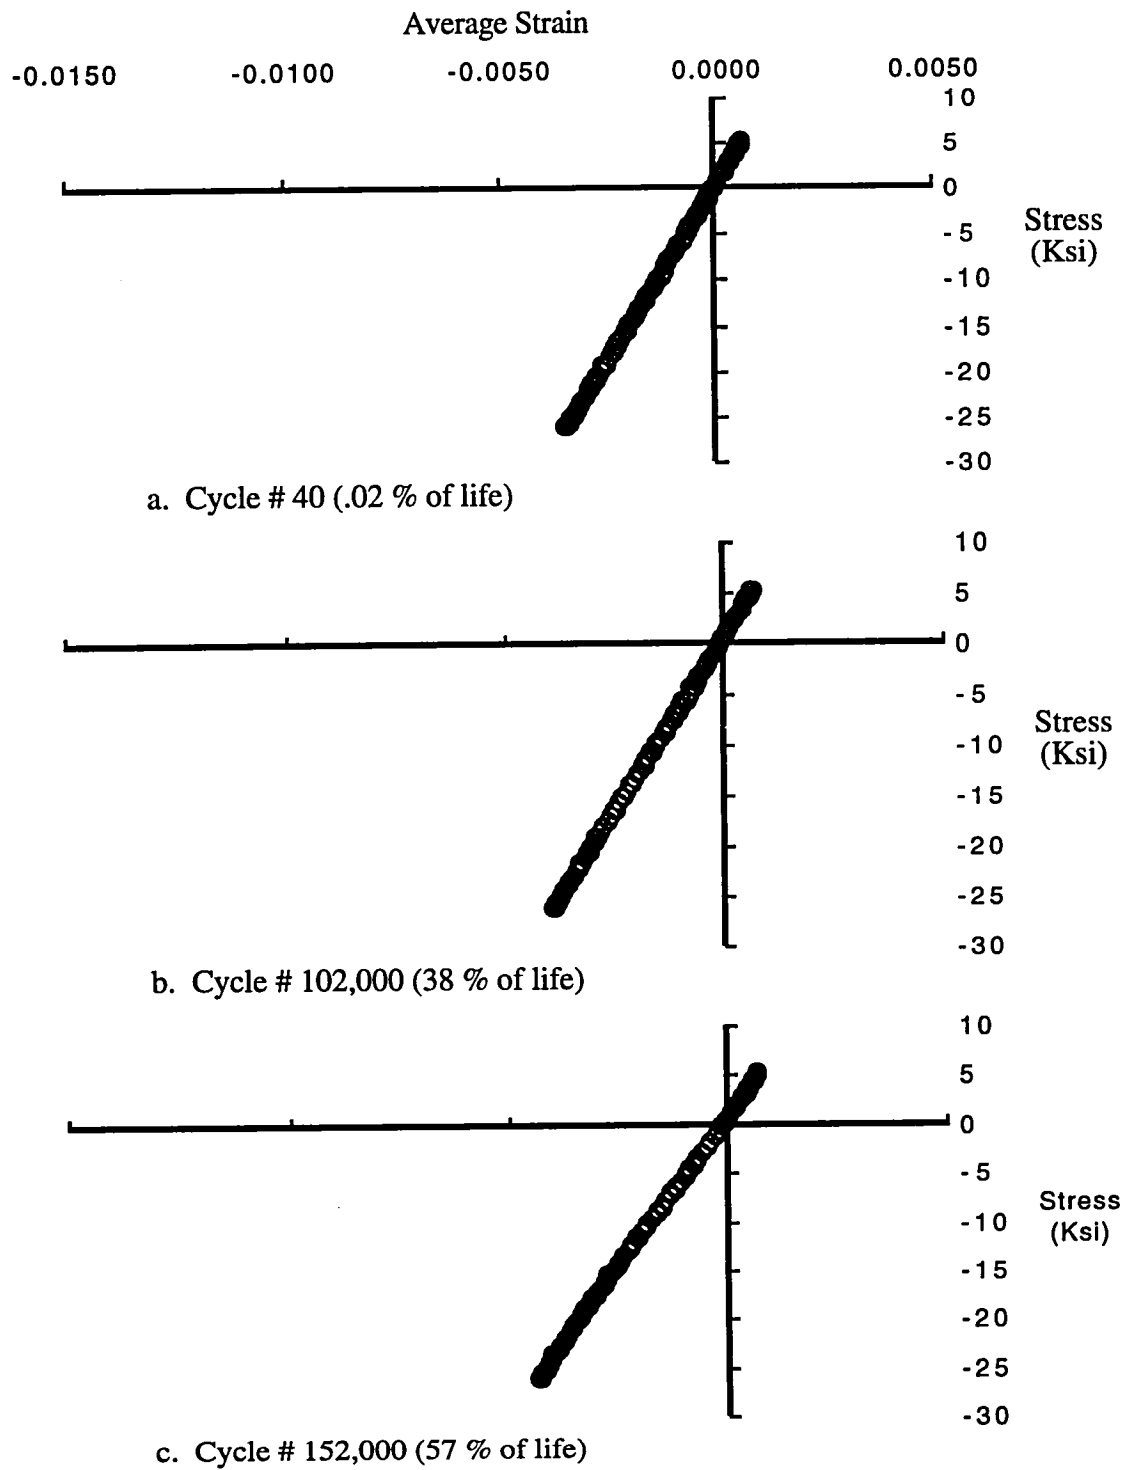
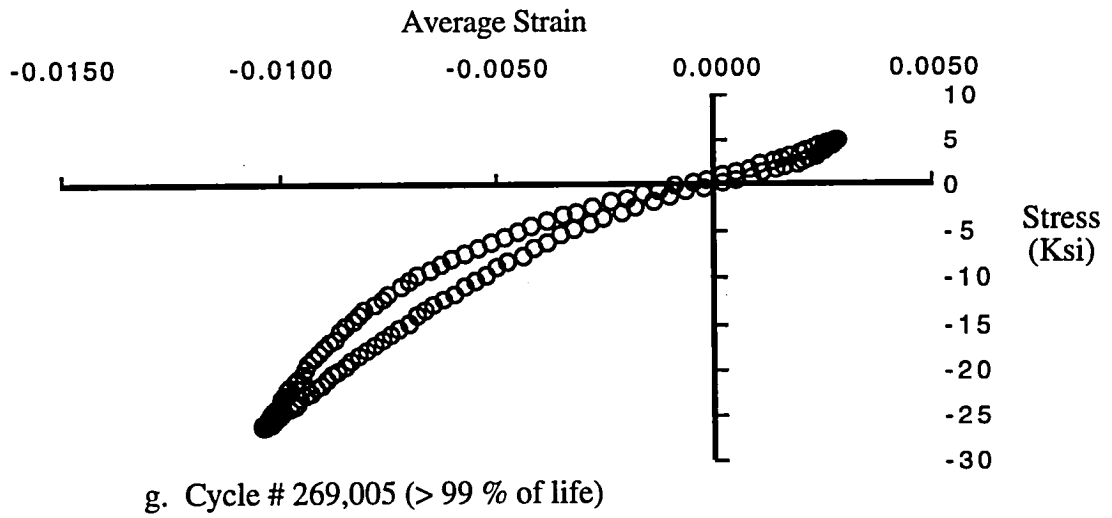
Figure 29. Far-field stress versus average strain across impact site during a typical fatigue test (IM6 TTT reinforcement).

Changes in size and shape of the stress-strain curve were monitored throughout each fatigue test by observing changes in hysteresis, maximum and minimum strain, and moduli. The hysteresis energy (actually strain energy density) is the area enclosed by the stress versus strain curve. This area was approximated by numerical integration using the

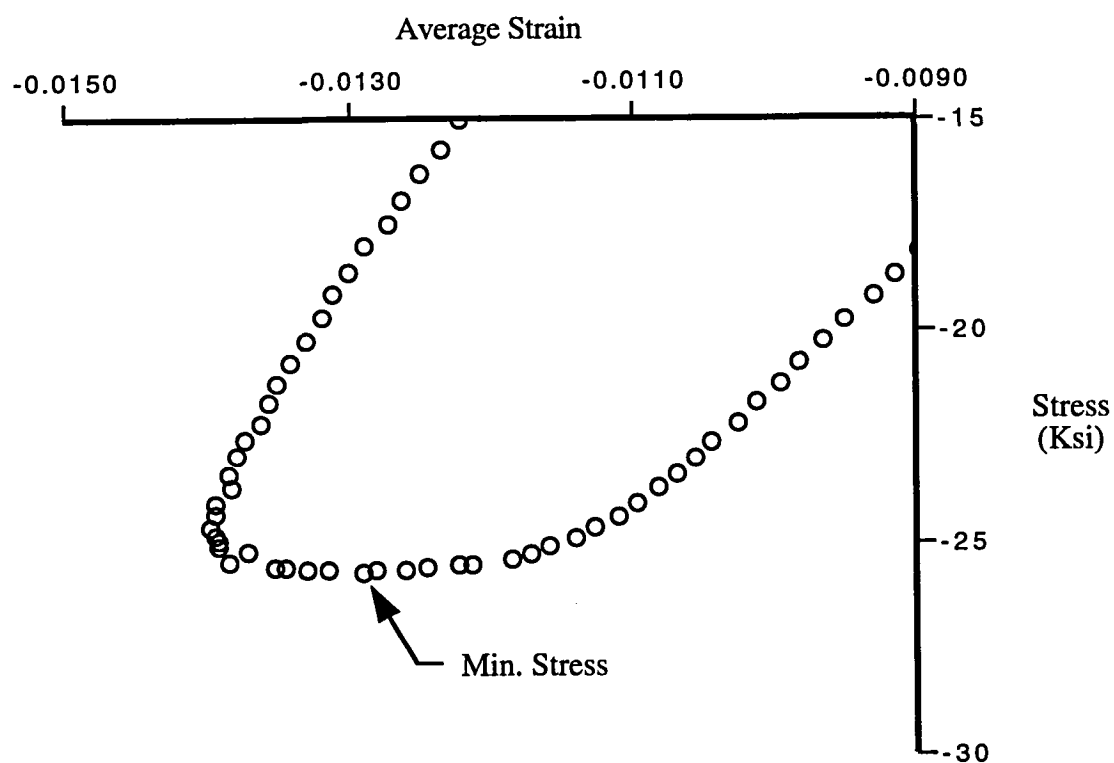
Figure 30. Far-field stress versus average strain at minimum stress during last full cycle of a typical fatigue test (IM6 TTT reinforcement).

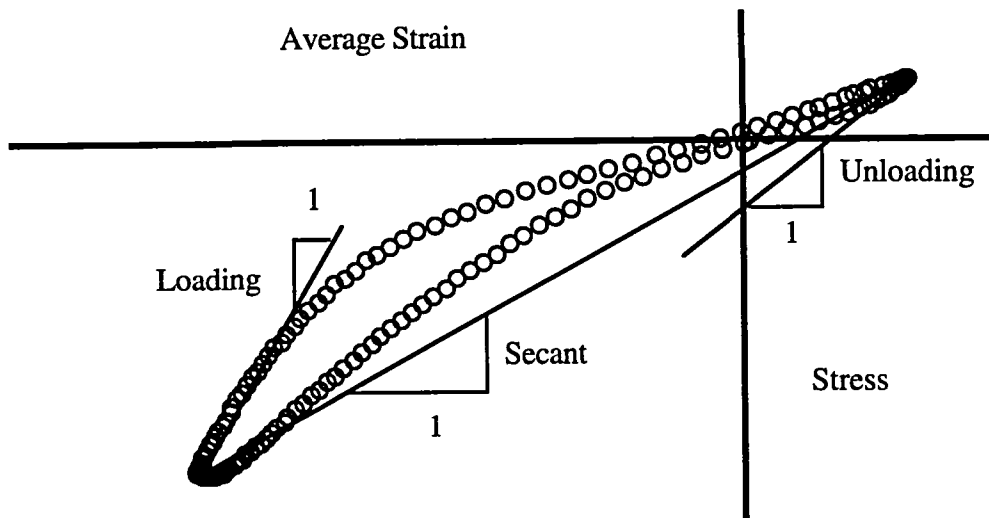
Figure 31. Definition of moduli.

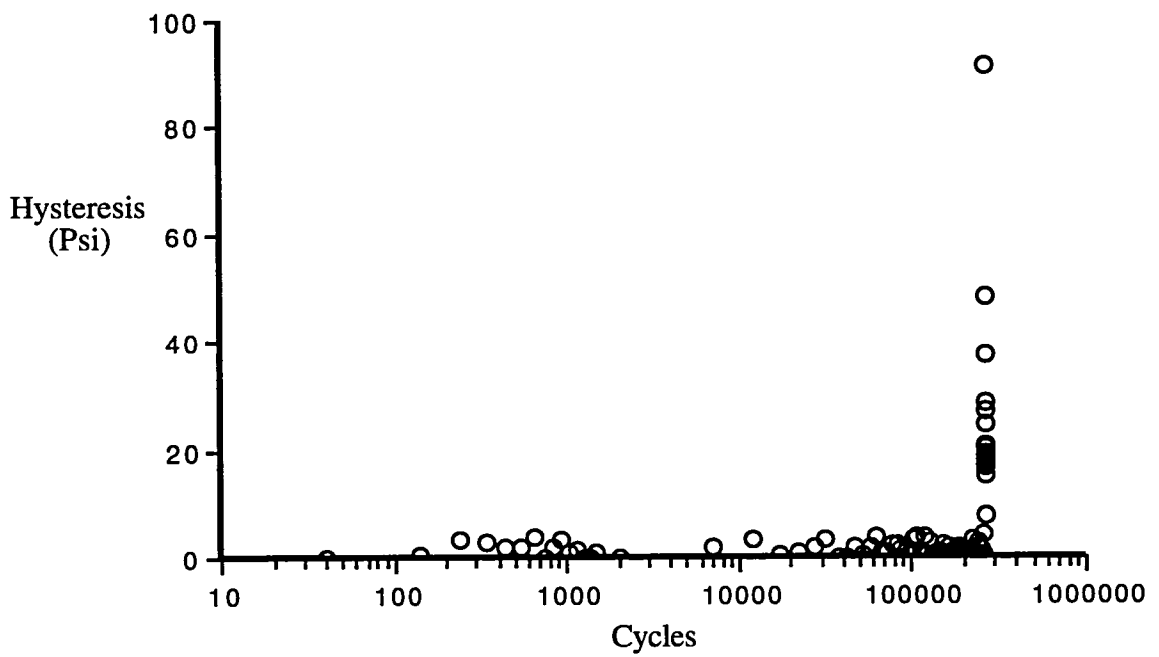
Figure 32. Changes in hysteresis throughout a typical fatigue test (IM6 carbon reinforcement).

However, hysteresis increased dramatically within the last 3% of fatigue life. According to the radiographic data, the majority of the damage growth during the initial 97% of life occurred through-the-thickness of the sample at the impact site, and damage rapidly grew transverse to the load direction from the impact site during the final 3% of life. This indicates that increases in hysteresis correspond to large increases in damage zone size (growth away from the impact site) and establish that failure is imminent.

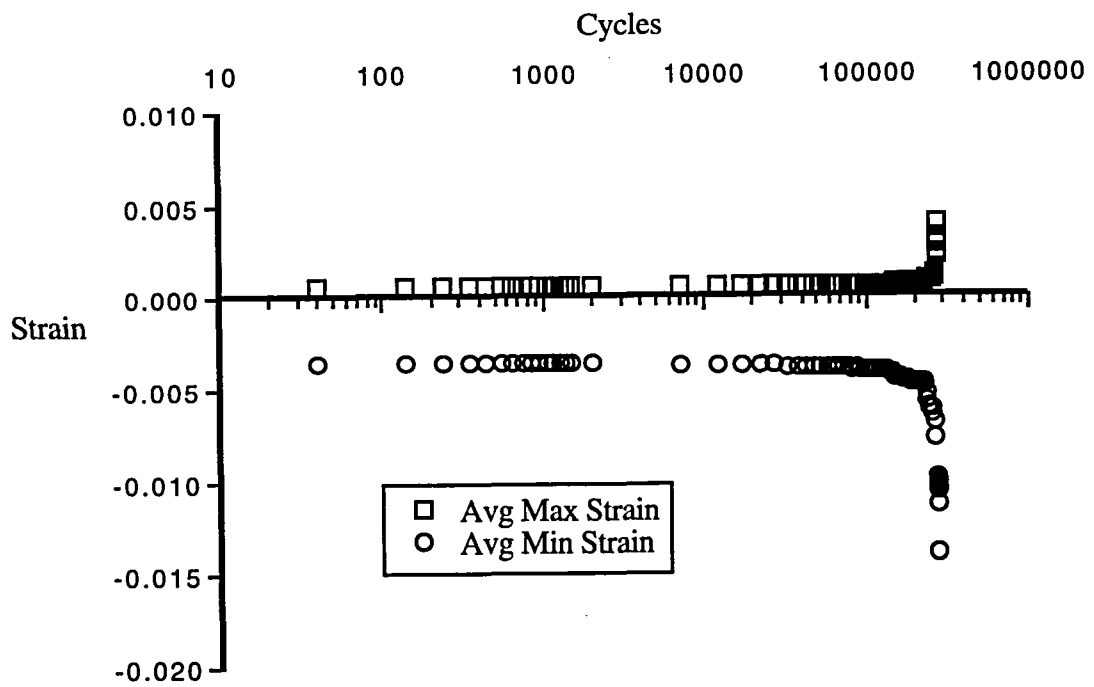
Figure 33. Changes in maximum and minimum strain throughout a typical fatigue test (IM6 carbon reinforcement).

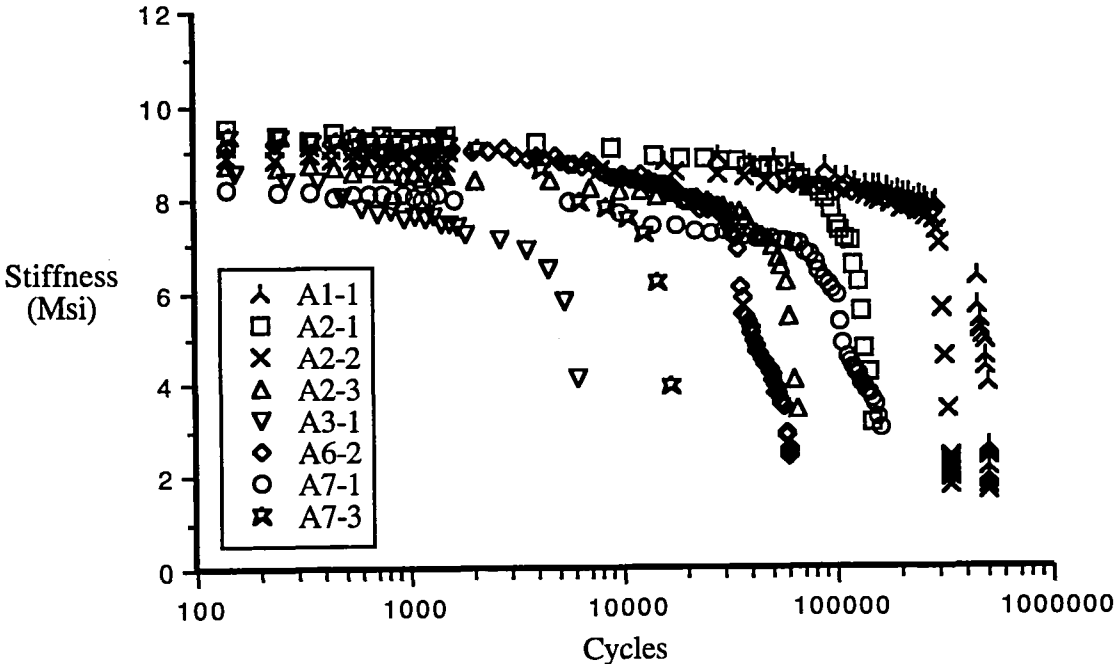
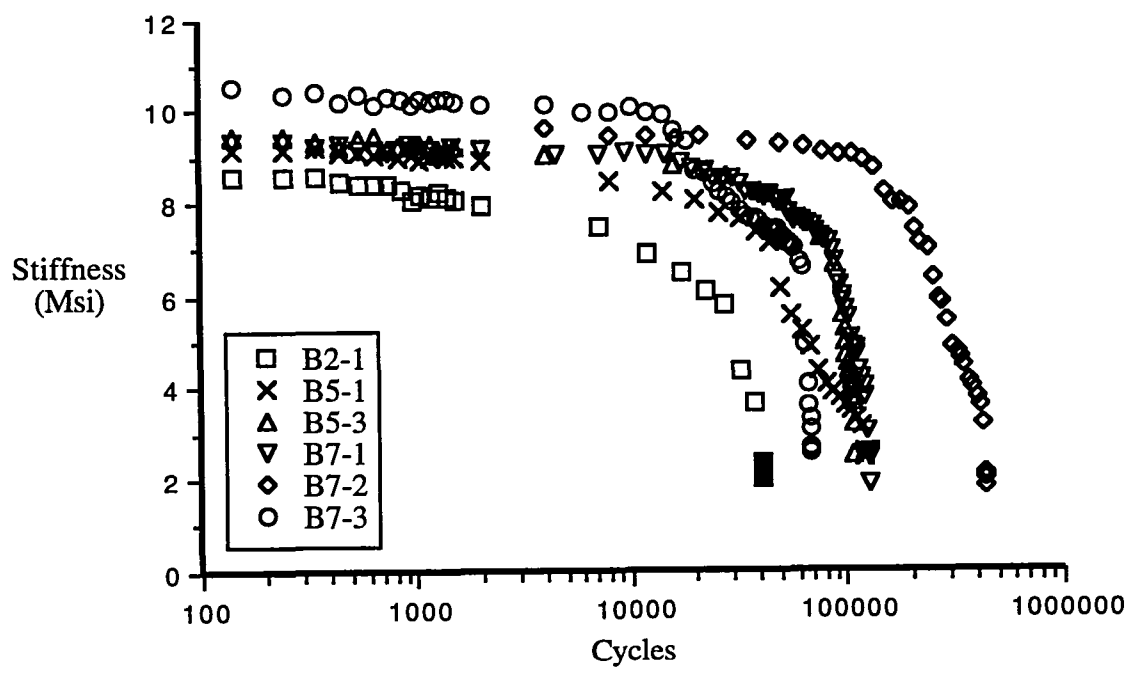
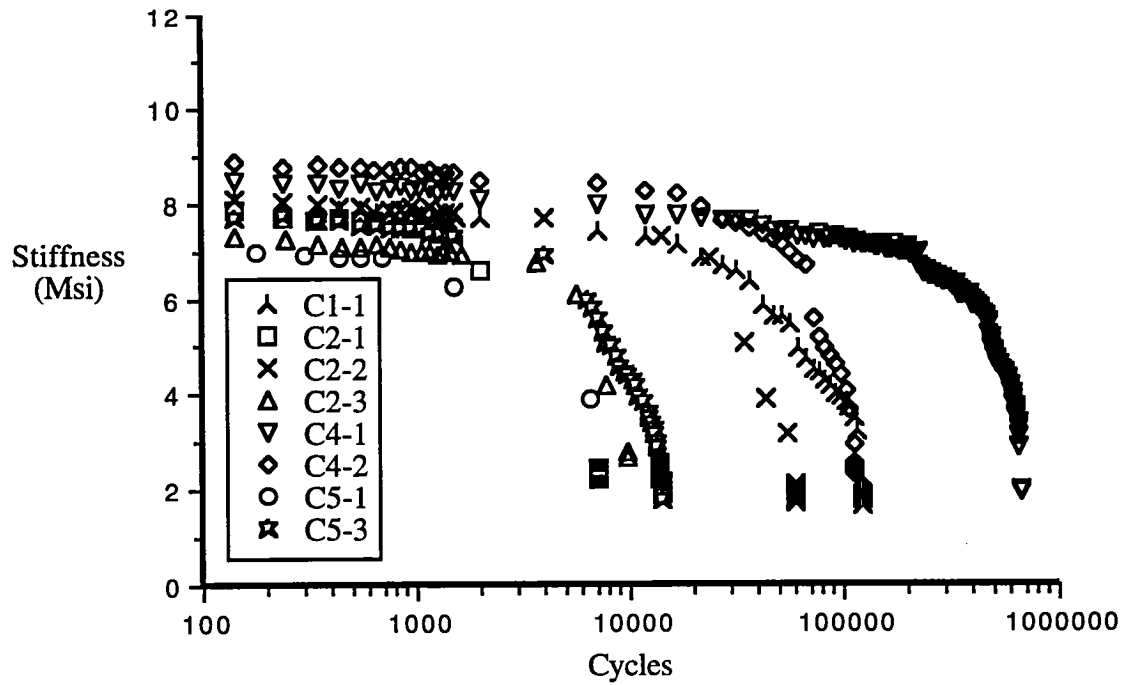
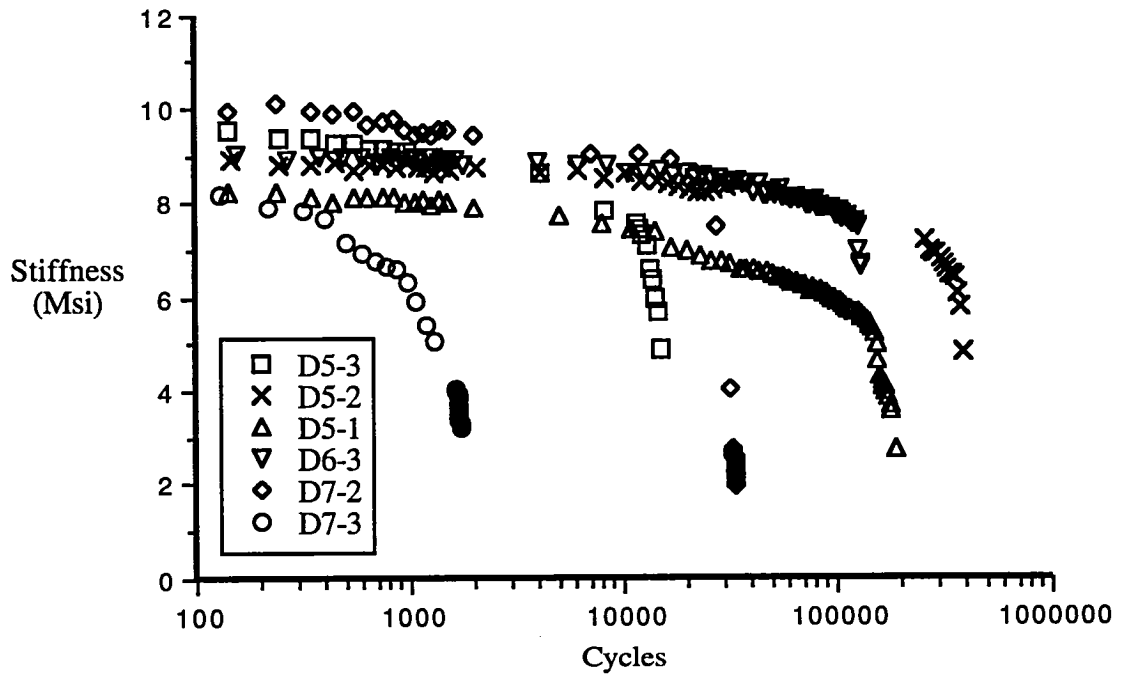
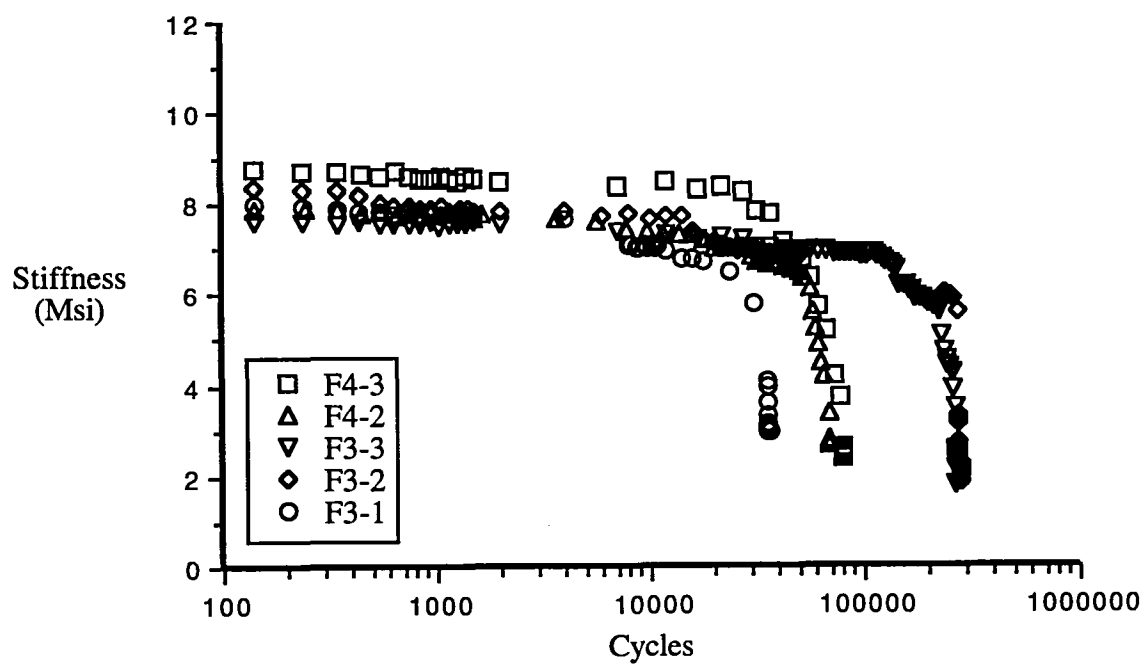
Figure 35. Stiffness loss throughout each fatigue test.

The stiffness loss curves were normalized to compare stiffness loss for samples with different fatigue lives, as shown in Figure 37. The number of cycles was normalized with the number of cycles to failure, and stiffness was normalized with the initial post-impact fatigue stiffness. Interestingly, the stiffness loss curves were similar for all samples and all TTT reinforcements tested. There were essentially three different stiffness loss regions, as shown in Figure 38. Typically, there was little stiffness loss in the first 50% of the test. There was significantly more stiffness loss over the next 47% of the test. And, the stiffness dropped dramatically over the final 3% of the test. Although there was some

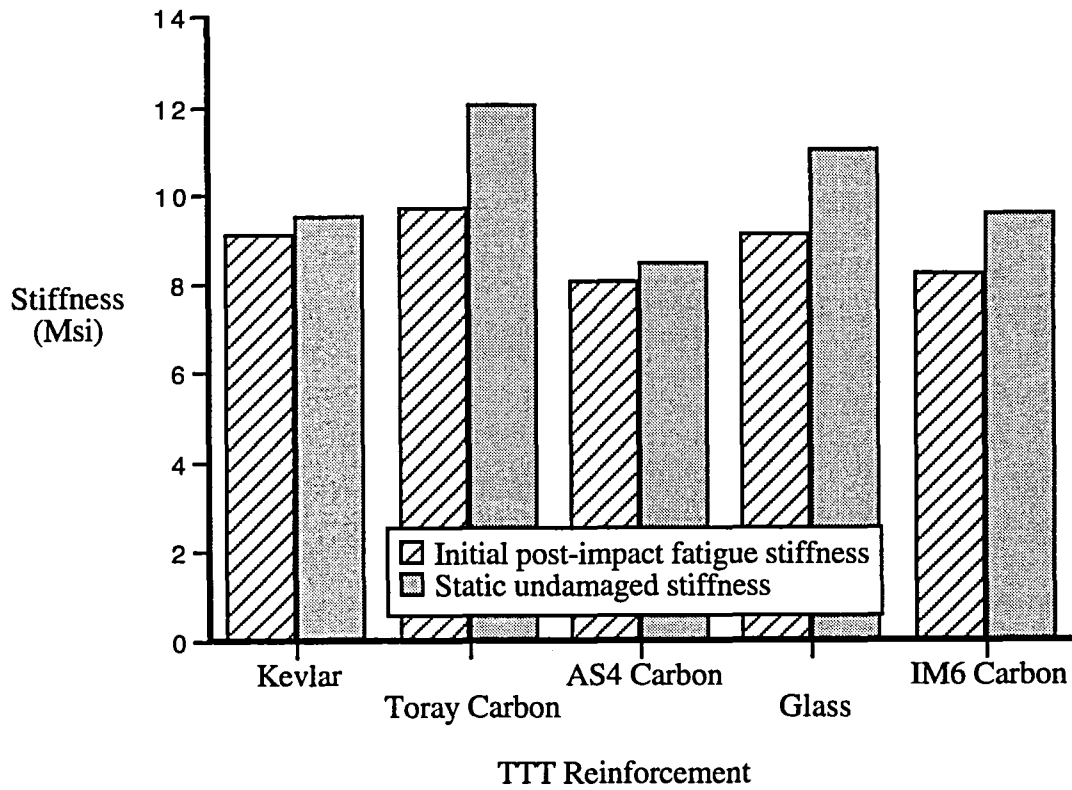
Figure 36. Average initial post-impact fatigue and undamaged static stiffness for each TTT material.

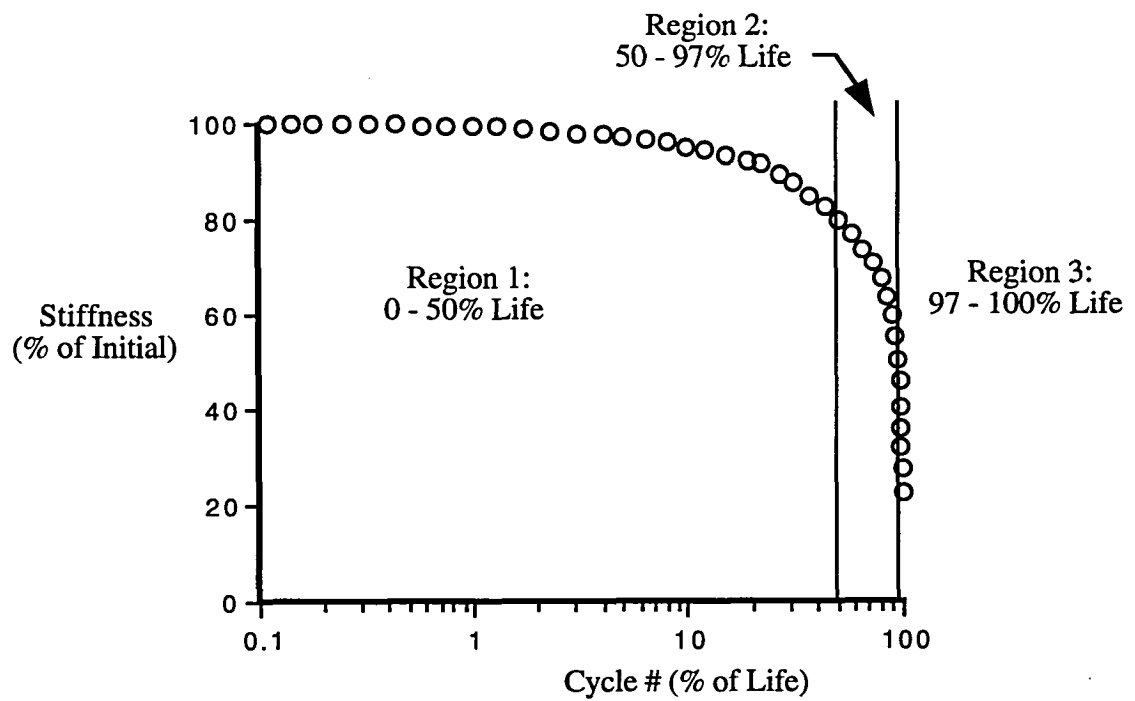
Figure 38. Stiffness loss regions.
